NATIONAL ADVISORY COMMITTEE FOR AERONAUTICS

TECHNICAL NOTE

No. 1095

MARINE EXPOSURE TESTS ON STAINLESS STEEL SHEET

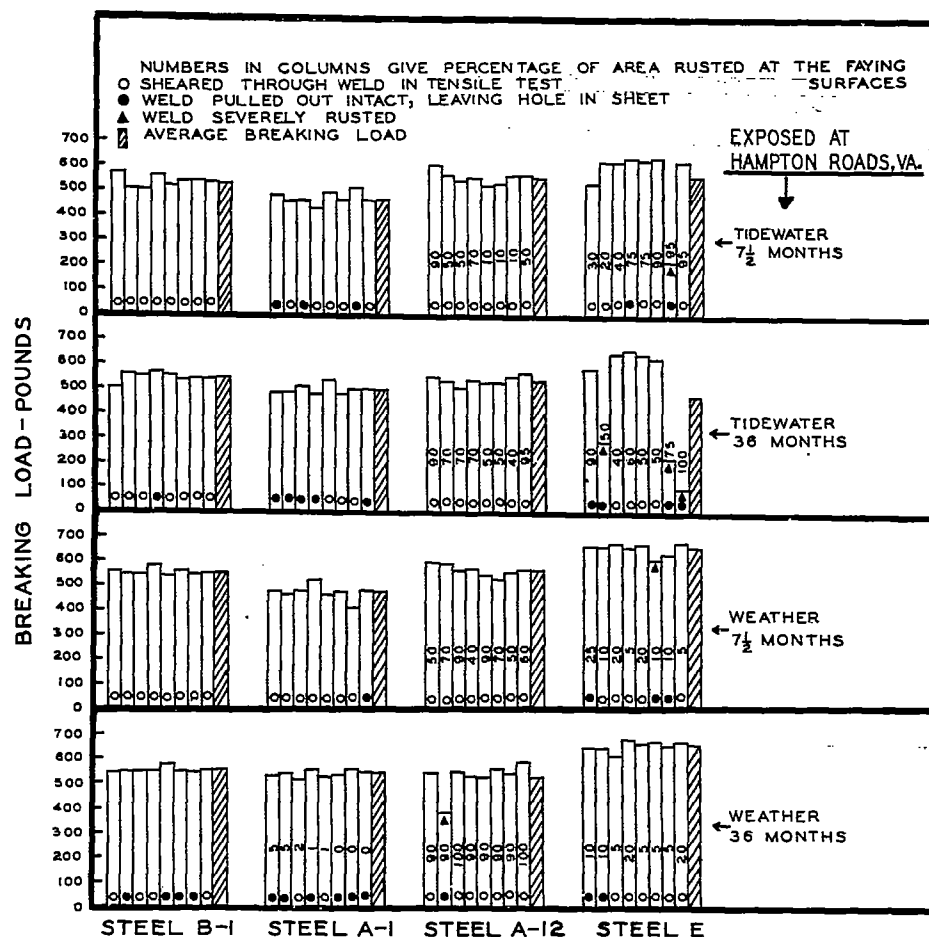
Representative results of the tensile tests on a few of the steels (fig. 24) reveal that, except for isolated instances on corroded welds, the range in breaking loads for the single welds was within narrow limits. The highest values were obtained on steel E. Tests made at the E. G. Budd Manufacturing Company on similar welds in this 16:1 type steel, showed that they would withstand a twist of only 10° before failure; whereas welds in the 18:8 type steels withstood a twist of 90° before failure. Shot welds in alloys corresponding to steel E probably would not prove as satisfactory as the austenitic type alloys for highly stressed structures.

Figure 24.- Results of tensile tests on individual shot-welds from representative panels after exposure at Hampton Roads, Va.

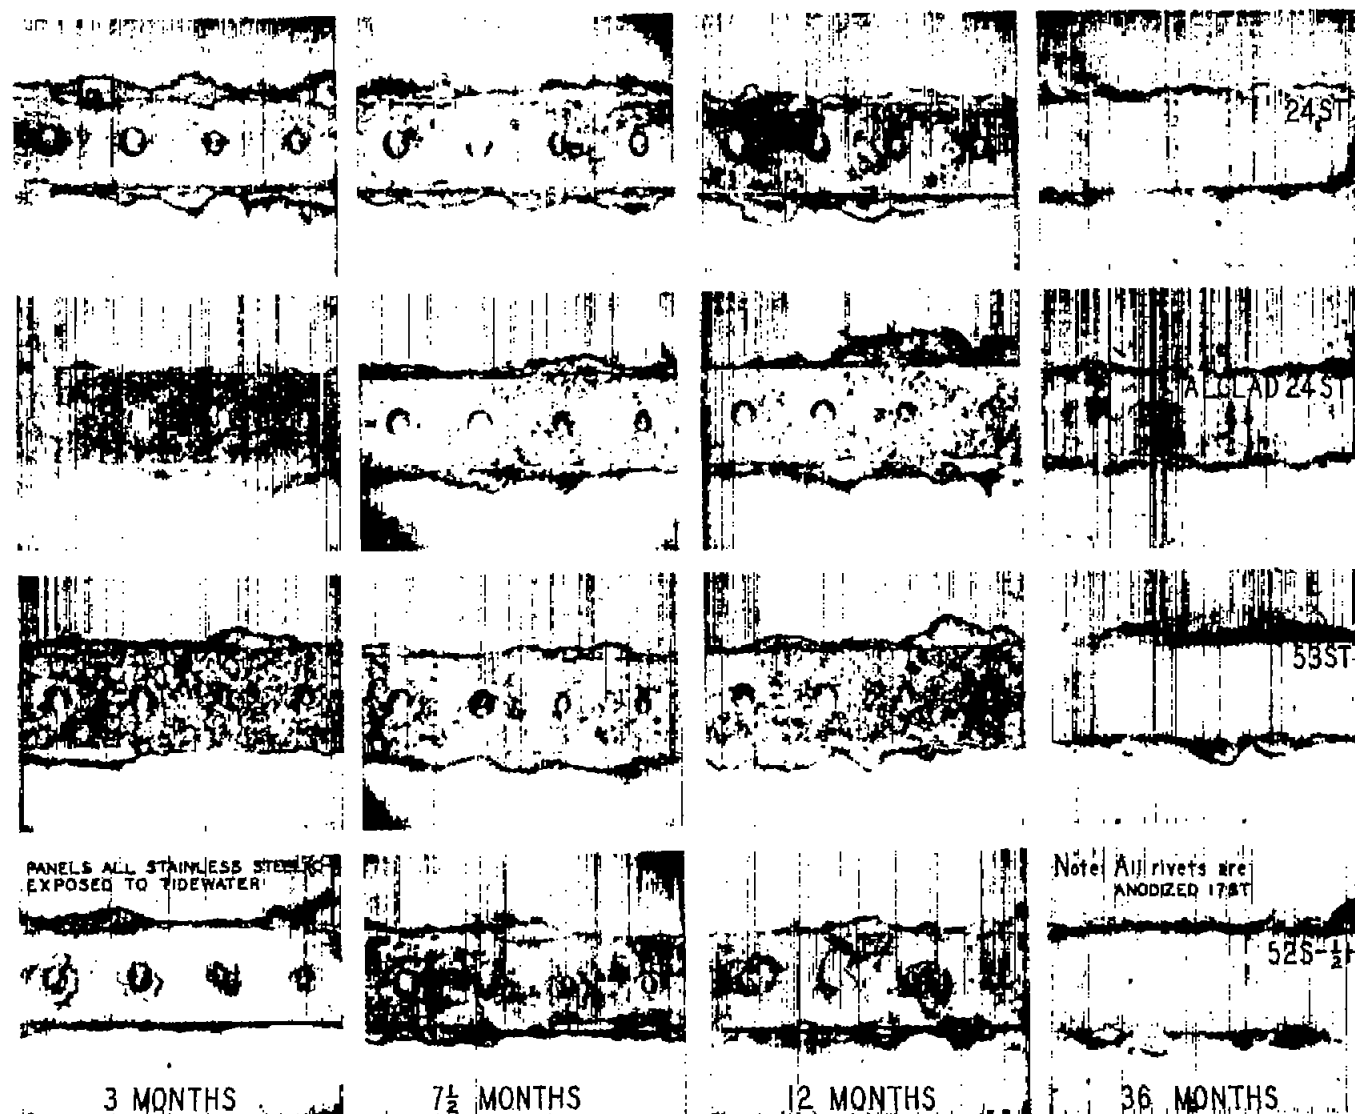
Both the macroscopic and microscopic examinations revealed that alloys 24S-T and Alclad 24S-T were the most severely attacked, with 53S-T somewhat less so, and 52S-1/2H the least. This does not necessarily indicate the order of the potential differences involved since the 52S-1/2H and Alclad 24S-T alloys are inherently the most resistant to corrosion.

Figure 28.- Strips of aluminum alloys, coupled in a 1:7 area ratio on panels of stainless steel, and exposed to the tidewater at Hampton Roads, Va. for the periods indicated. Note the severe corrosion on the strips and the quantities of corrosion products accumulated at the edges of juncture. x 1/2.

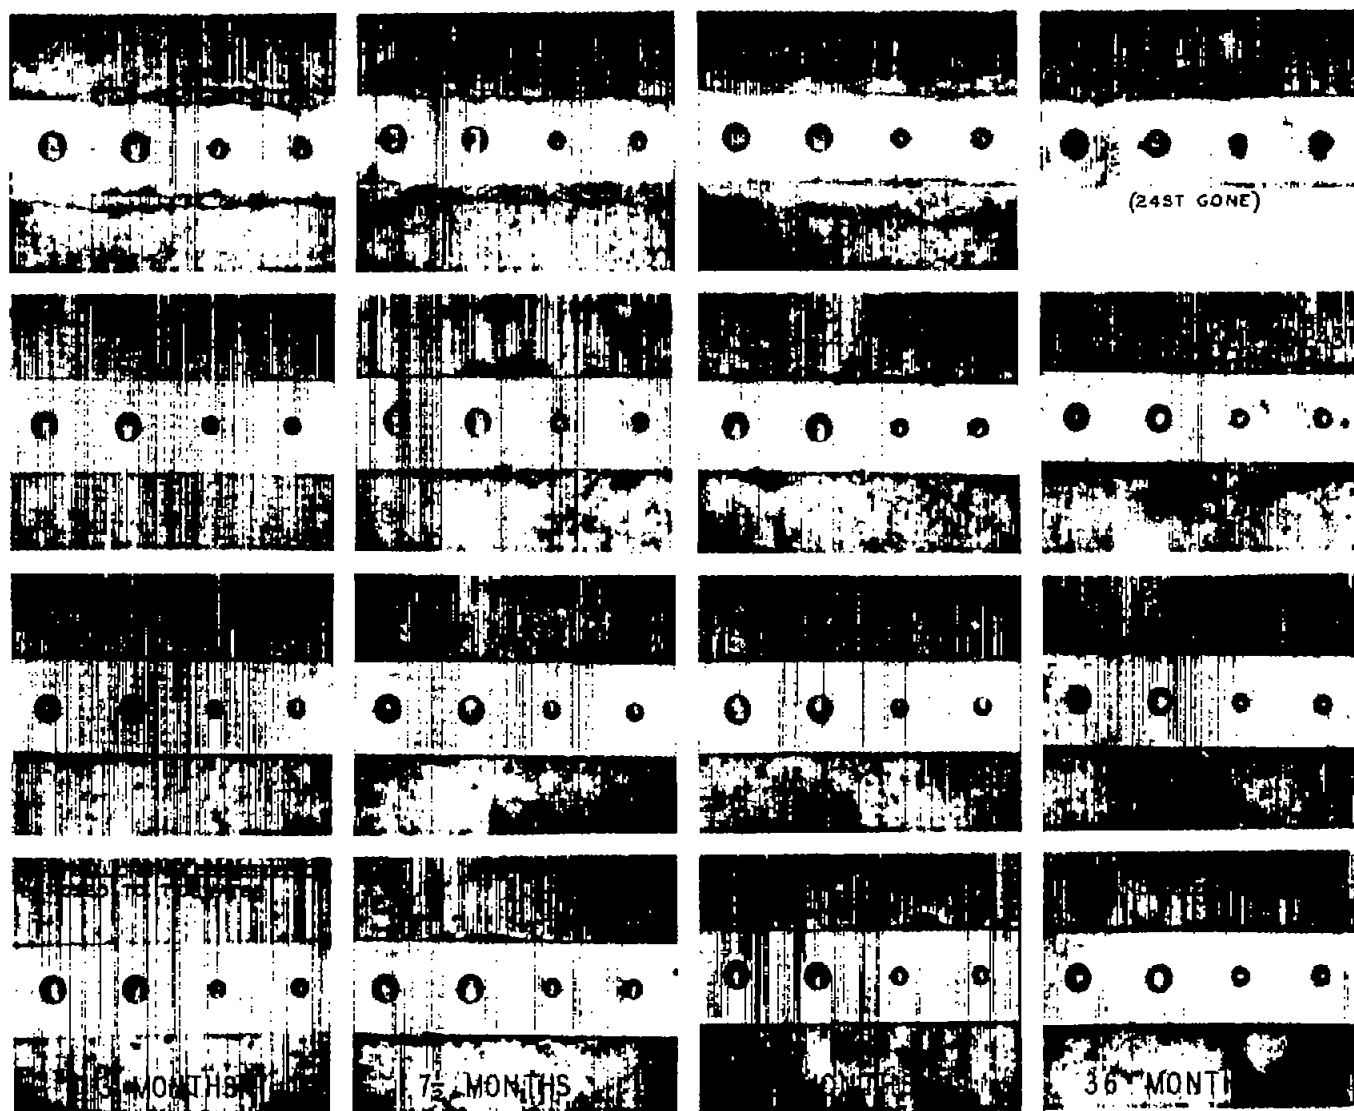
Figure 29.- Strips of stainless steel, coupled in a 1:7 area ratio with panels of aluminum alloys, and exposed to the tidewater at Hampton Roads, Va. for the periods indicated. Note that the aluminum alloys are less severely attacked, and the quantities of corrosion products at the edges of juncture are less than in figure 28. $\times 1/2$.

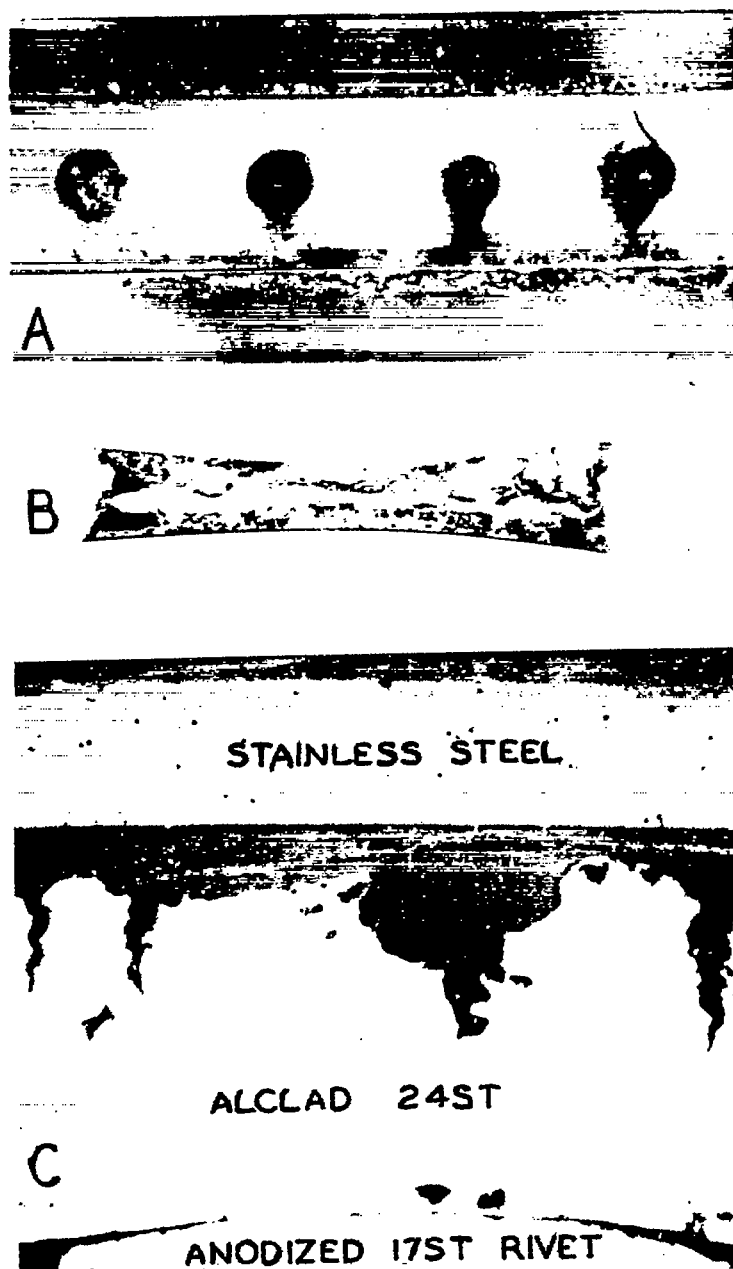
years corrosion products at the faying surfaces (fig. 31A and 31B) were sufficient in quantity to cause stress corrosion cracking of the stainless steel strips. The paint between the faying surfaces on the painted panels afforded excellent protection, and severe corrosion at the couples was not noted until after the second year of weather exposure (fig. 34).

Figure 31.- Examples of stress corrosion on panels having stainless steel coupled with light metal alloys. A, Crack on stainless steel strip joined to a magnesium alloy panel, Dowmetal M. Exposed two years to the weather, earthward surface. x 1. B, Cross-section showing the large amount of corrosion products at the faying surfaces of (A). x 2-1/2. C, Cracks in Alclad 24ST strip attached to a stainless steel panel, exposed to tidewater for two years. x 50.

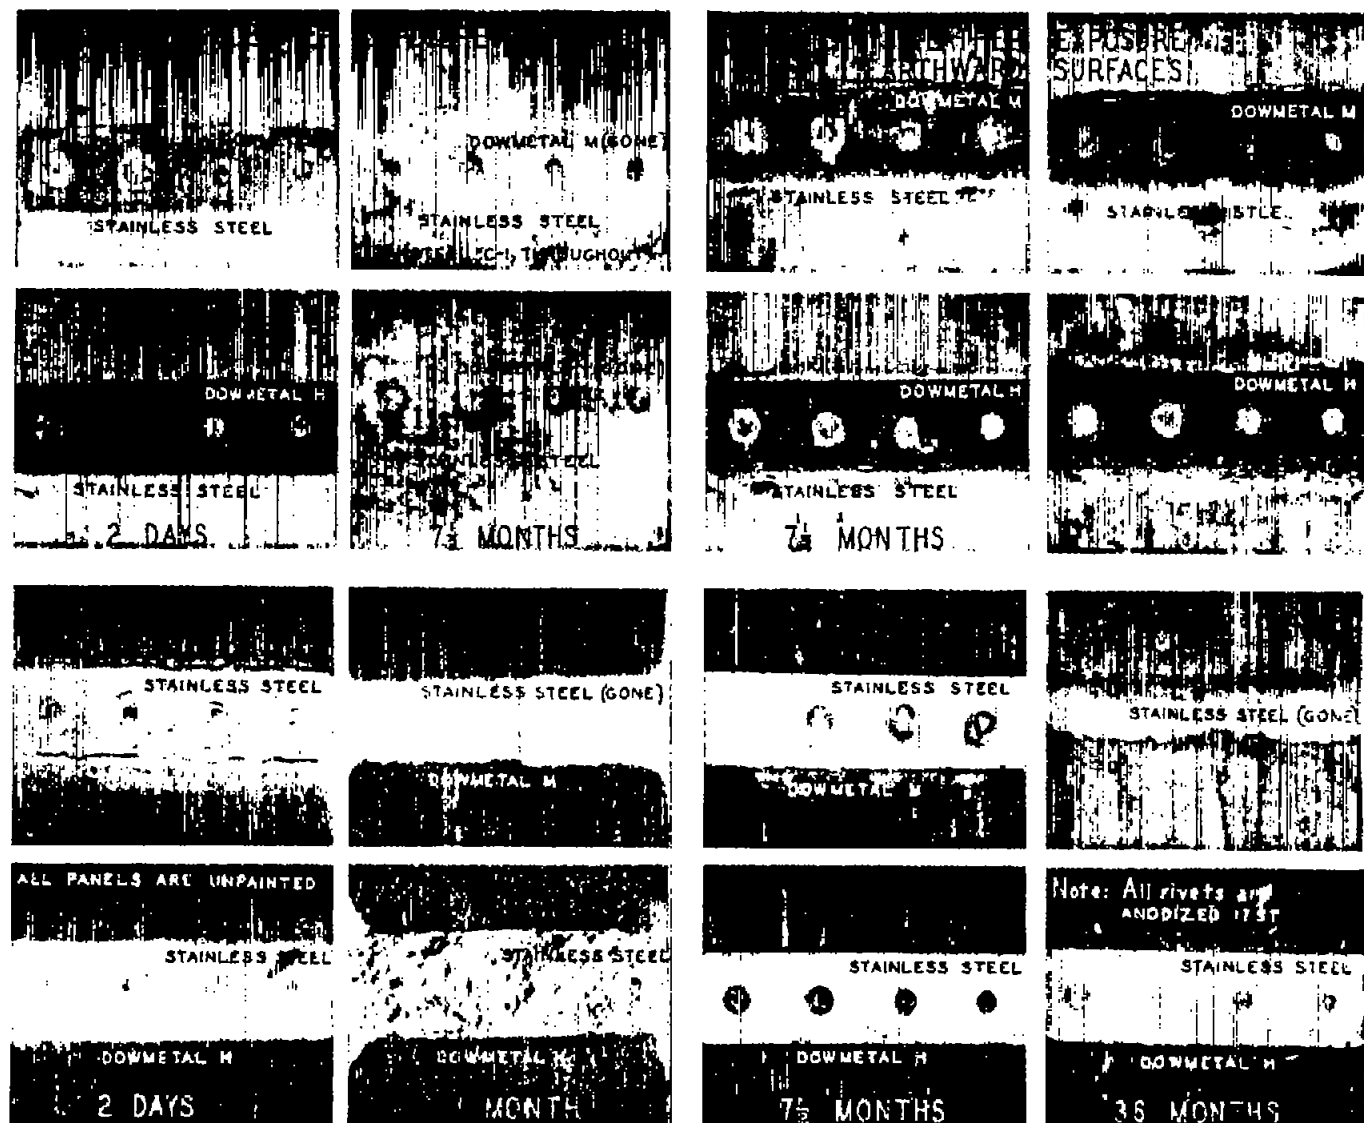
Two unpainted magnesium alloys, Dowmetals M and H, were very severely attacked when coupled with stainless steel, especially when exposed to tidewater at Hampton Roads. Immediately after the first tidewater had covered these panels, violent bubbling of the water occurred, and the reaction was audible at a distance of approximately 15 feet. An adherent white corrosion product was deposited on the steel, which attained a thickness of 0.004 inch on the second day of exposure (fig. 33), at which time the first set of unpainted panels was removed. The white deposit gradually disappeared, and the underlying steel was found unattacked. The Dowmetal M was attacked somewhat more rapidly than the Dowmetal H. The unpainted panels were removed from the tidewater racks after 1/15, 1, 3, and 12 months, while panels painted prior to exposure (fig. 34) were removed from the tidewater racks after 1, 3, $7\frac{1}{2}$, and 12 months. The paint schedule consisted of 1 coat of zinc chromate primer and 3 coats of aluminum-pigmented varnish (Navy Specification V10-d).

Figure 33.- Unpainted panels exposed at Hampton Roads, Va., for the periods indicated, having stainless steel and magnesium alloys in contact with each other. Note the electrolytic deposition of white corrosion products on the uncorroded steel, on panels exposed to the tidewater. The upper quadrants show Dowmetal strips on steel; the lower quadrants show the reverse arrangement. x 1/2.

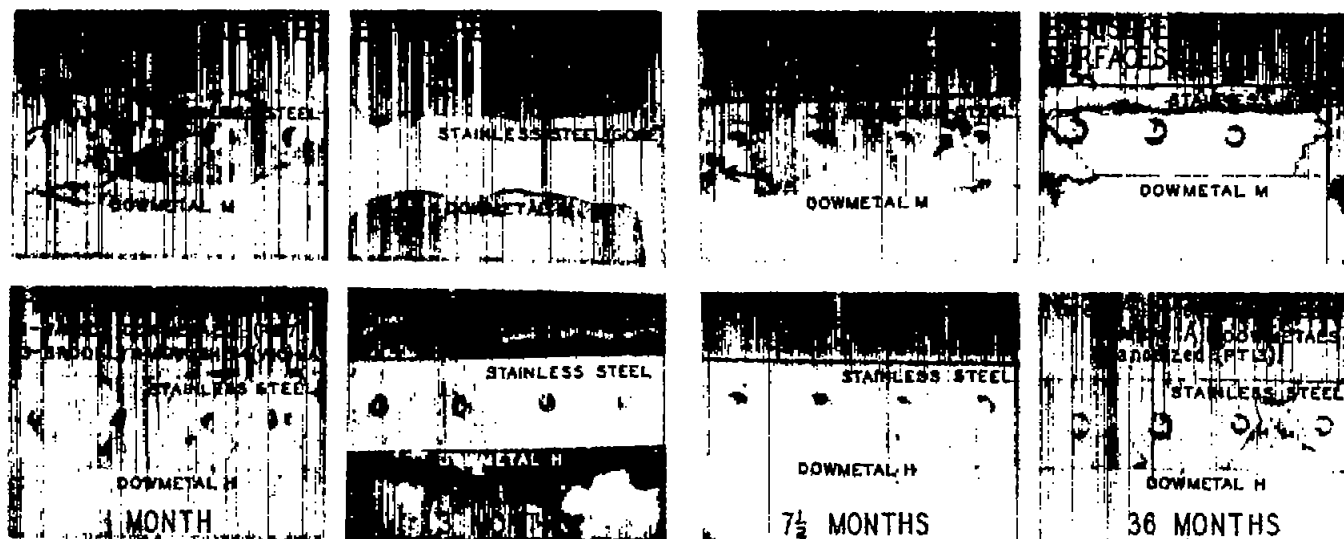
Figure 34.- Painted panels, comparable with those shown in figure 33, after exposure at Hampton Roads, Va. Note that the paint afforded little protection against tidewater exposure, and that it began to fail to adhere to the stainless steel strips after 7-1/2 months of weather-exposure (arrows). x 1/2.
